PROYECTO FINAL DE CARRERA

Patología estructural y del casco:

Métodos de protección, inspección, mantenimiento y reparación

Ingeniería Naval y Oceánica
Junio, 2014

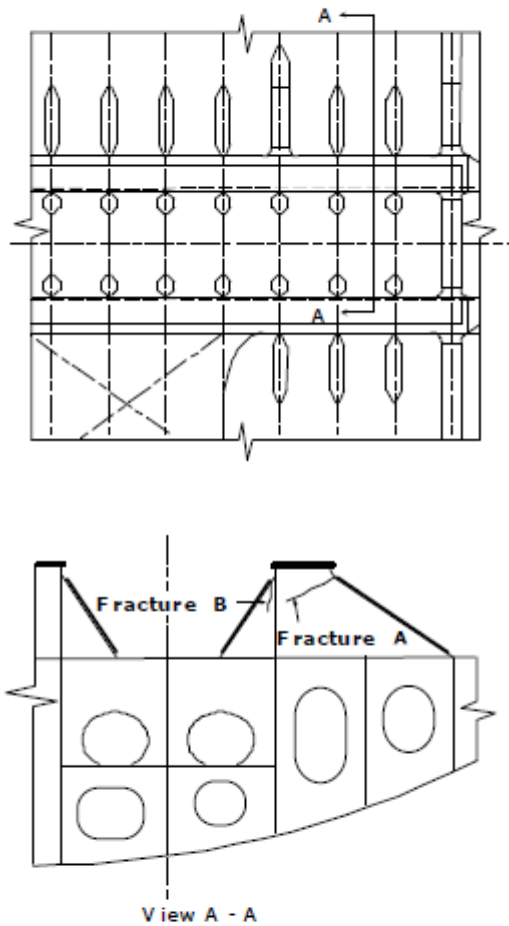
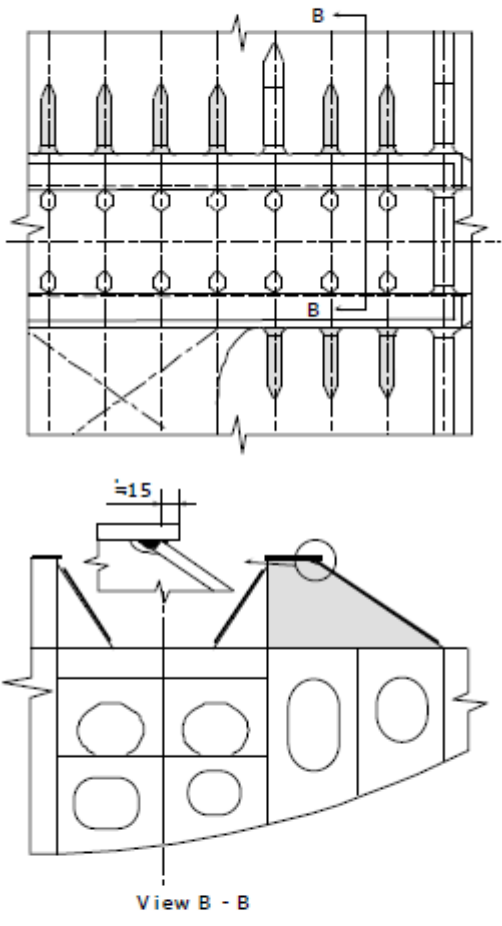
Guidelines for Surveys, Assessment and Repair of Hull Structure		
Part 3	Machinery and accommodation spaces	Example No.
Area 1	Engine room structure	1
Detail of damage	Fractures in brackets at main engine foundation	
Sketch of damage		Sketch of repair

Notes on possible cause of damage 1. Vibration of main engine. 2. Insufficient strength of brackets at main engine foundation. 3. Insufficient pre-load of the bolts.		Notes on repairs 1. Fractures may be veed-out and 2. rewelded. New modified brackets at main engine foundation. Or insert pieces and additional flanges to increase section modulus of the brackets.

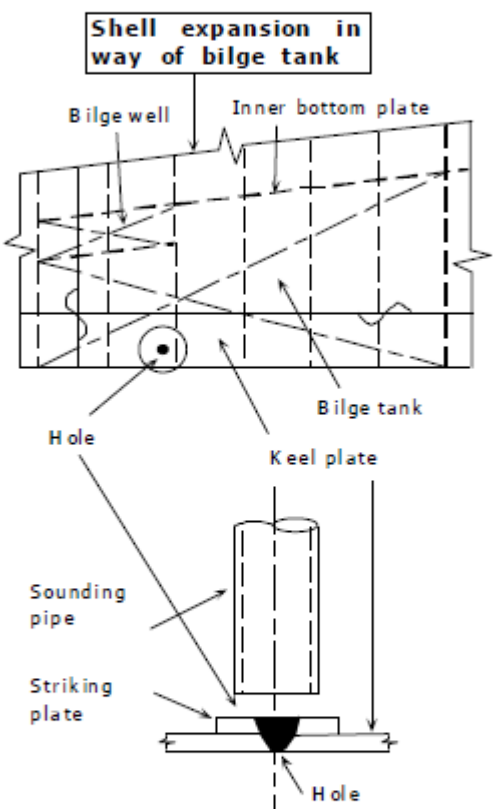
Guidelines for Surveys, Assessment and Repair of Hull Structure		
Part 3	Machinery and accommodation spaces	Example No.
Area 1	Engine room structure	2
Detail of damage	Corrosion in bottom plating under sounding pipe in way of bilge storage tank in engine room	
Sketch of damage

Notes on possible cause of damage 1. Heavy corrosion of bottom plating under sounding pipe.		Notes on repairs 1. Corroded striking plating should be renewed. 2. Bottom plate should be repaired depending on the condition of corrosion. (Note) Repair by spigot welding can be applied to the structure only when the stress level is considerably low. Generally this procedure cannot be applied to the repair of bottom plating of ballast tanks in cargo hold region.

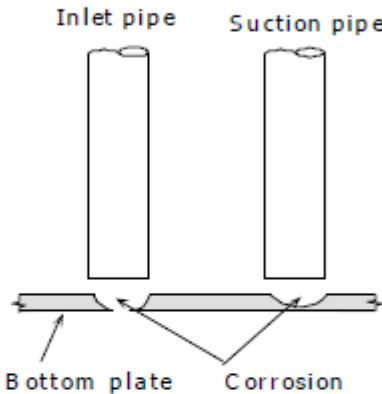
Guidelines for Surveys, Assessment and Repair of Hull Structure		
Part 3	Machinery and accommodation spaces	Example No.
Area 1	Engine room structure	3
Detail of damage	Corrosion in bottom plating under inlet/suction/pipe in way of bilge tank in engine room	
Sketch of damage

Notes on possible cause of damage 1. Heavy corrosion of bottom plating under the inlet/suction pipe.		Notes on repairs 1. Corrode bottom plate is to be cropped and part renewed. Thicker plate is preferable. 2. Replacement of pipe end by enlarged conical opening (similar to suction head in ballast tank) is preferable.
